**The Clarendon Building  
Conservation Plan**

Building No. 144  
April 2013

**Estates Services**  
**University of Oxford**  
**April 2013**

## CONSERVATION PLAN

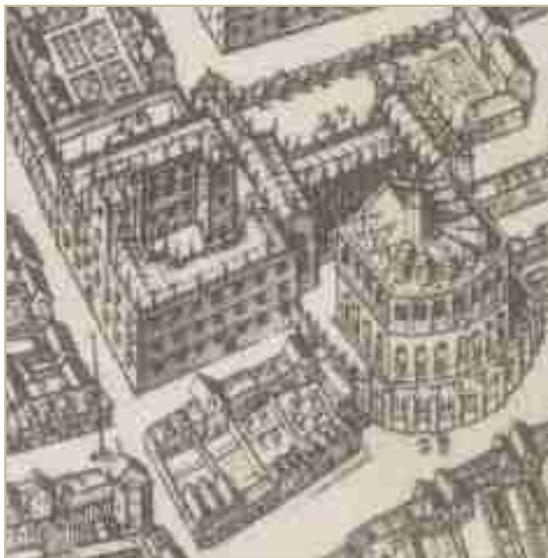
**Figure 2. Excerpt from Loggan's 1675 plan of Oxford. North is at the bottom of the image**

(**Figures 2 and 3**) shows, the site of the Clarendon Building was the location of several post-mediaeval tenements and the short-lived late-17<sup>th</sup>-century wooden printing house.

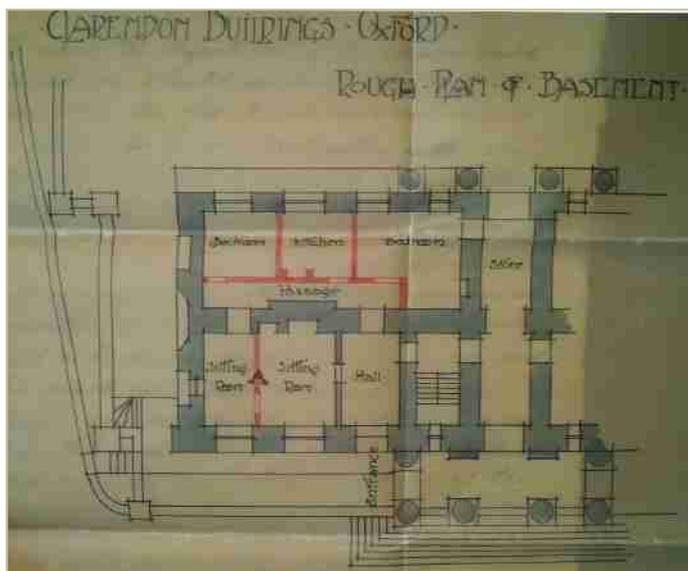
**Figure 5. A.J. Rowley's 1902 plan of the basement with north at the bottom of the image. The brick partitions affected by downwards settling are drawn in red, with the wall marked 'A' of particular concern**

(Underground Rooms) of the 1891 Public Health (London) Act. The act did not cover Oxford, but was presumably thought by the University to represent best practice. The floors on this side of the basement were lifted and excavated down, to give the rooms a minimum height of 7 feet. The soil beneath was covered with concrete and fitted with a woodblock floor. Fireplaces and associated flues and ventilation were fitted to all the rooms of the flat and a new window was fitted at the eastern edge of the flat's passage (in the lowest southern niche of the eastern elevation).<sup>39</sup> The lowering of the floor levels in the eastern side of the basement subsequently caused issues, as in 1902 the internal brick partitions were found to have settled downward, leaving gaps between the walls and the ceiling (**Figure 5**). The gaps were filled but the walls continued to shift and in 1903 were demolished and replaced with cement partitions with reinforced concrete foundations.<sup>40</sup>

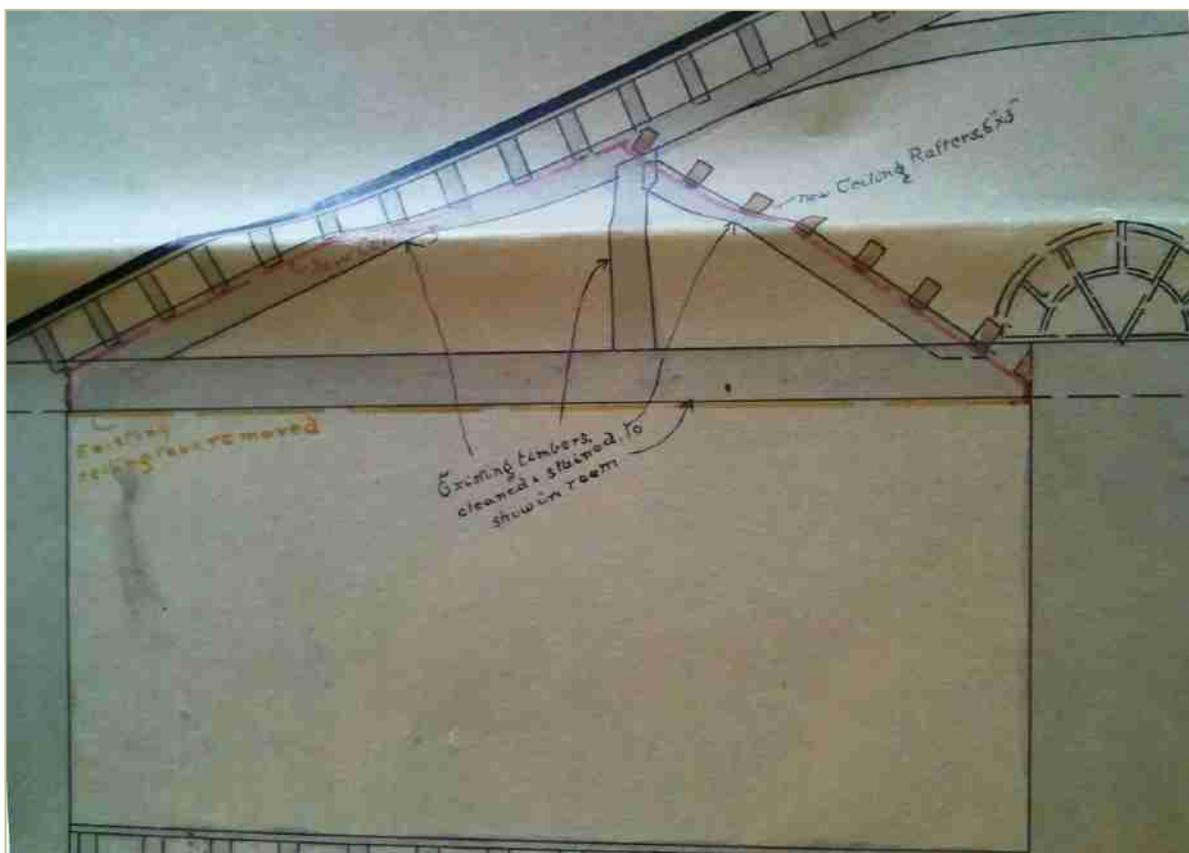
**Figure 6. Section of 1902 attic ceiling alterations for the Association of the Education of Women**

The Association for the Education of Women, which occupied the western side of the attic, expanded into the eastern side of the attic in 1901-2 and consequently occupied the entire top floor. Several alterations were necessary to facilitate their occupation of the eastern half of the attic including: the removal of the previous flat ceiling and the installation of new ceilings and ceiling joists above the newly-stained and polished rafters, which were left exposed (**Figure 6**); and the installation of new fireplaces in the rooms which did not already have them.<sup>41</sup> The ceiling and floor of the space over the portico (which at this point had limited access and was being used for storage) was also repaired in 1902.

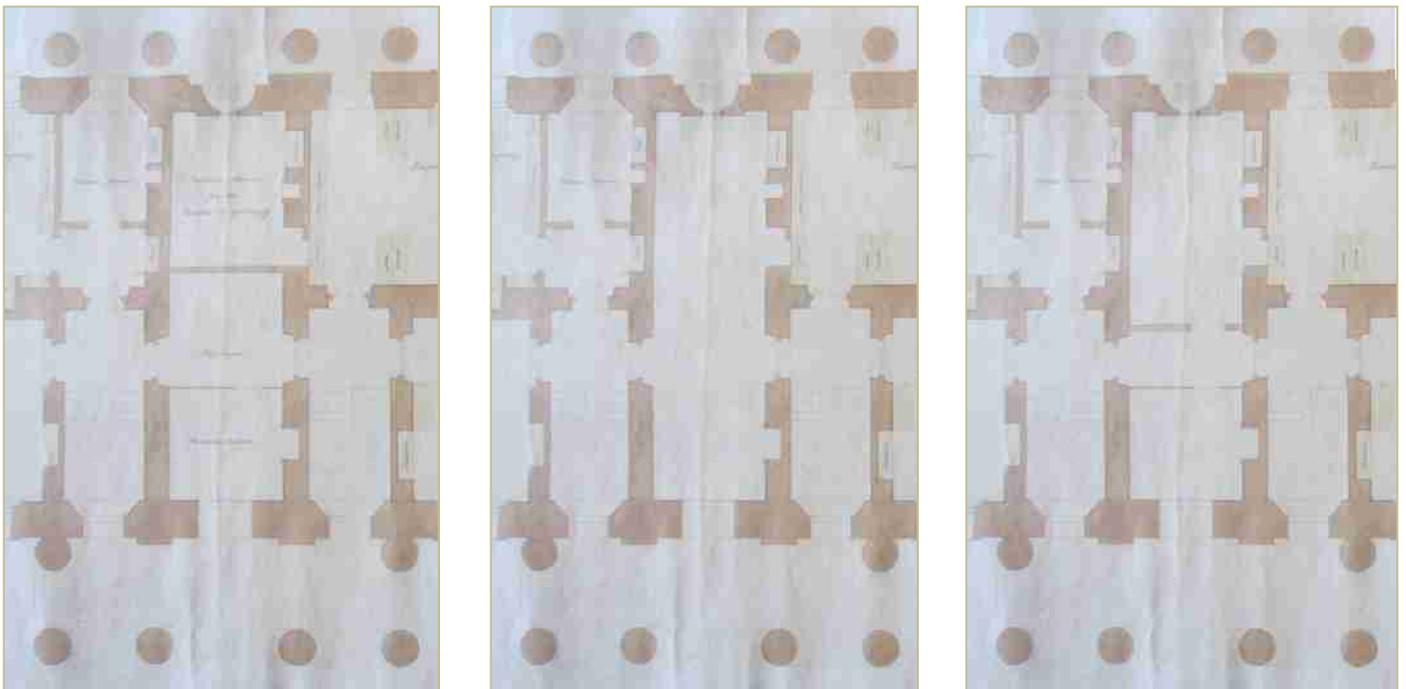
**Figure 7 Changes to the first-floor transept. 7.1, left, extract from Smirke's 1831 plan. 7.2, centre, projected state of the space by 1901. 7.3, right, probable state of the space following 1901-2 alterations. All plans orientated with north at the bottom**

By 1902, all of the partitioning in the first-floor transept that is visible in Smirke's 1831 plan had been removed, creating a single long room running the N-S length of the building (**Figure 7**). In 1902, a private room was created in the northern portion of the space for the Appointment's Committee (who already occupied the north-western quarter of the floor), with a partition being fitted in the same position followed by the extant 2005 partitions which replaced them (**Figure 7.3**). In the following year the Delegacy for the Training of Secondary Teachers took over the southern portion of the transept, fitting another partition in the position of the extant one, creating a narrow passage connecting the two staircases. They also enlarged the curved window in the central southern niche at this time, making it two feet wider and six inches higher than it had previously been.<sup>42</sup>

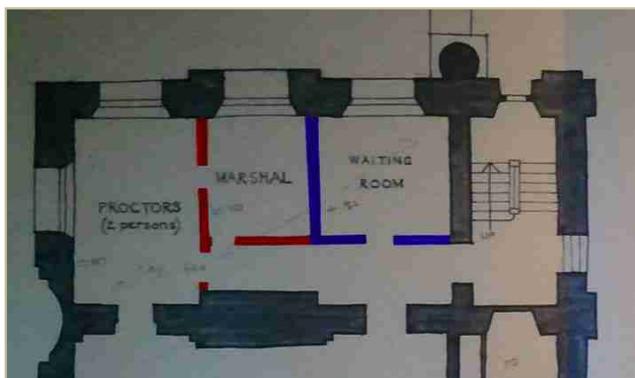
**Figure 8. The north-western part of the ground floor in 1962. The partitions highlighted in red were removed in 1975. Those highlighted in blue were removed in 1992**

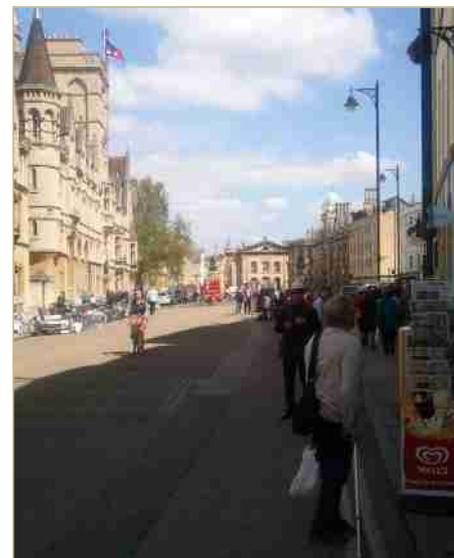
**Figure 9. The view eastwards up Broad Street**

The western and northern façades of the Clarendon Building are definitive features in the character of Broad Street. Looking eastwards up the length of Broad Street from its western end, the terminus of one’s view is dominated by the western elevation of the Clarendon Building, with its bold pediment, and by the projecting portico of its northern elevation (**Figure 9**).

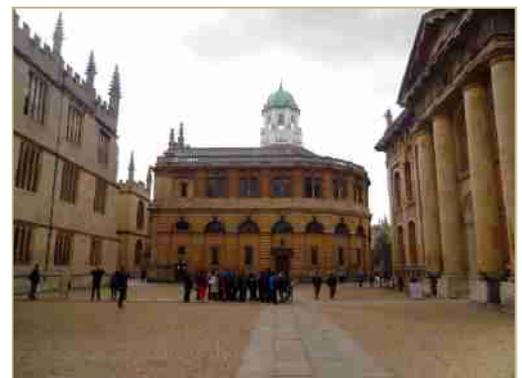
**Figure 11. The Clarendon Quadrangle looking westwards**

The southern and eastern elevations of the building are amongst the defining features of Cattle Street. The openness of Clarendon Quadrangle means that as one moves north up the street, these elevations become increasingly visible. The southern elevation reads much as the north but with the portico relegated to an engaged frontispiece and lacking the monumental stairs. It is a unique experience to stand in the Clarendon Quadrangle with the Clarendon Building rising as a triumphal arch to the north, with the curve of the Sheldonian to the west, the Bridge of Sighs flying over New College Lane to the east, and the tall expanse of the northern range of the Old Schools Quadrangle rising to the south (**Figure 11**).

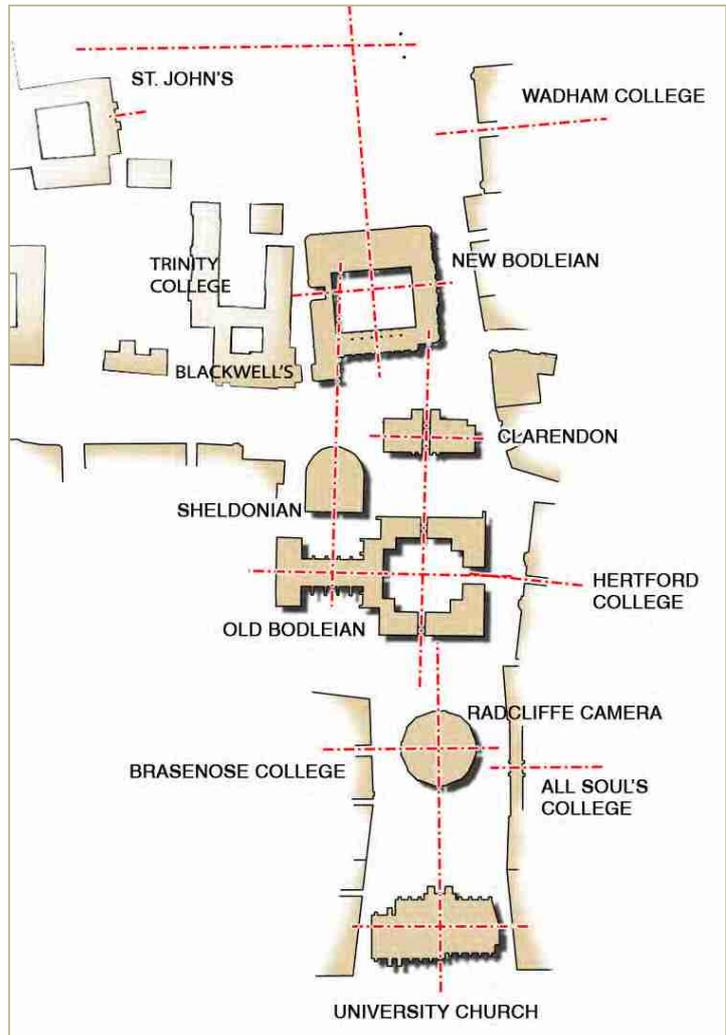
**Figure 12. The geometry of the Broad Street East-Catte Street-Radcliffe Square configuration**

As mentioned above, the effect of this grouping is that one can move from Broad Street and the New Bodleian through to Radcliffe Square and the Radcliffe Camera without leaving the University's monumental core. The significance of the Clarendon Building in this way is that it is a central component of the interacting monumental centrepiece of both the city and University (as in monumental function the two are indistinguishable) that is the conjunction of Broad Street East, Catte Street, Radcliffe Square, and their associated buildings. The Clarendon Building originally marked the northern boundary of this configuration, but this was extended by the construction of the New Bodleian in 1936-7. The presence of the road between these two disrupts the relationship somewhat; however, this will be enhanced by the reopening of the New Bodleian as the Weston Library in 2015, which will further integrate this building with Broad Street.

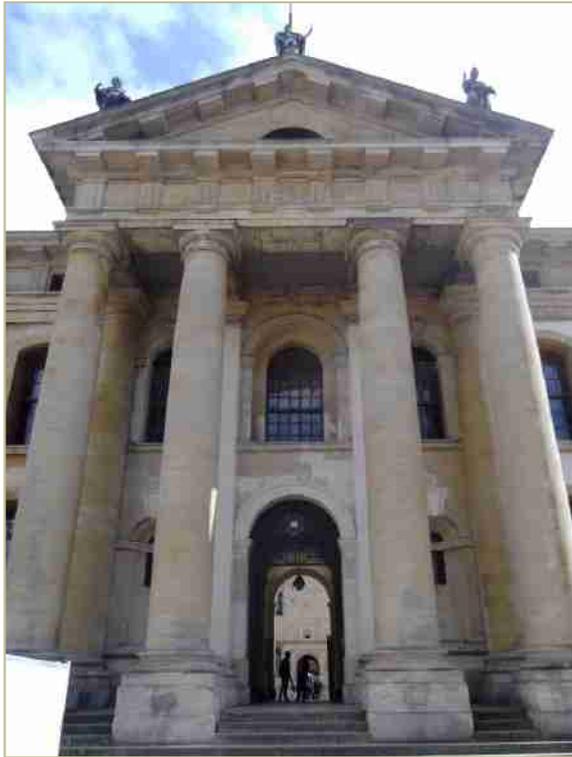
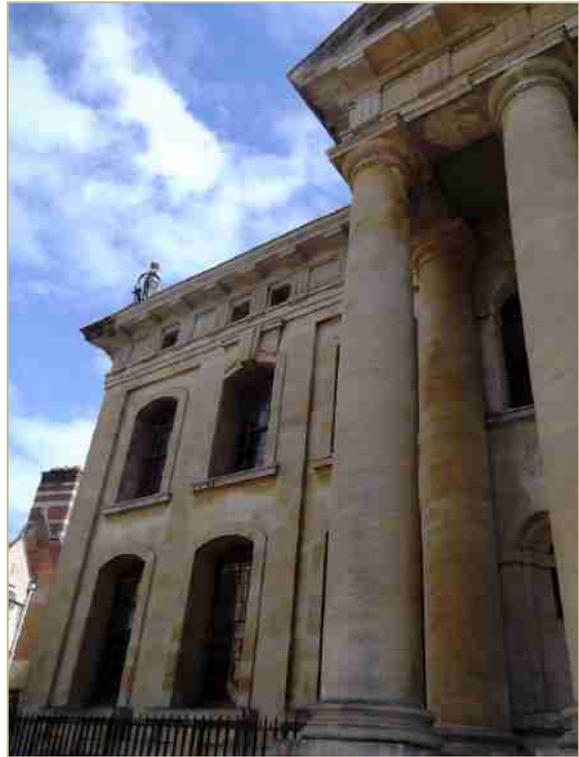
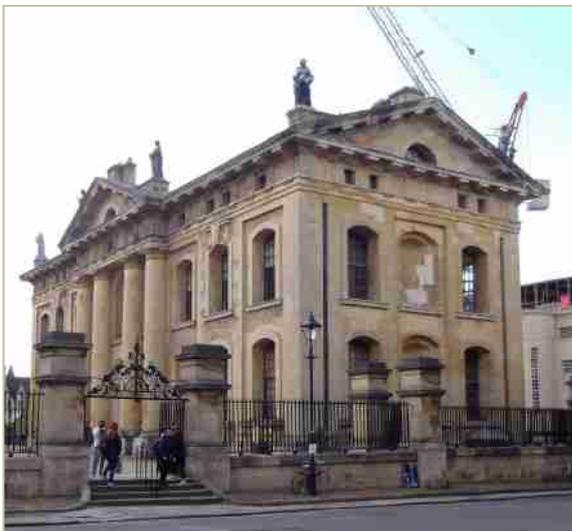
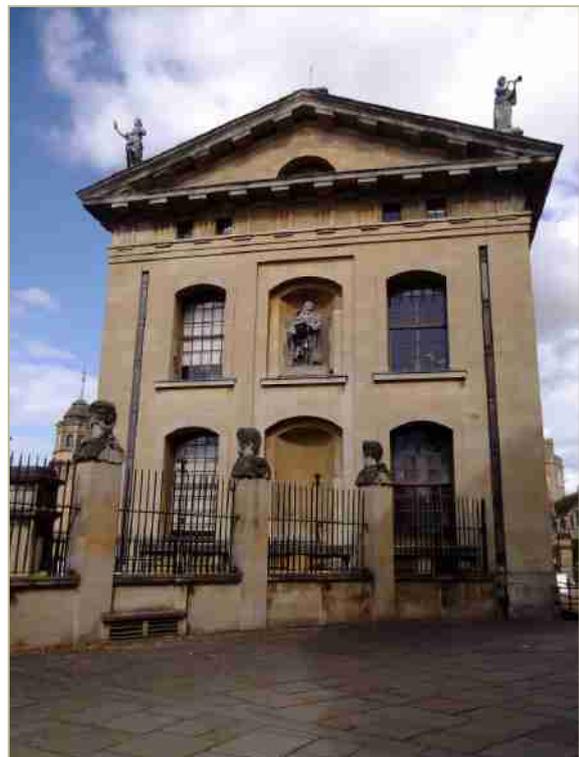
**Figure 13. 13.1, top left, the portico looking southwards from Broad Street. 13.2, top right, the eastern side of the northern elevation, looking south-eastwards from Broad Street. 13.3, bottom left, the eastern and southern elevations looking north-westwards from Cattle Street. 13.4, bottom right, the western elevation looking eastwards from outside the Sheldonian Theatre**

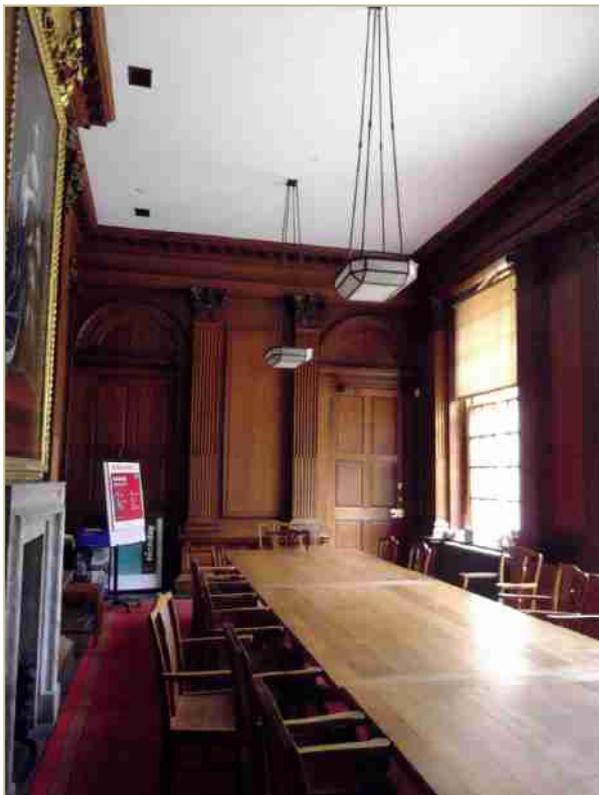
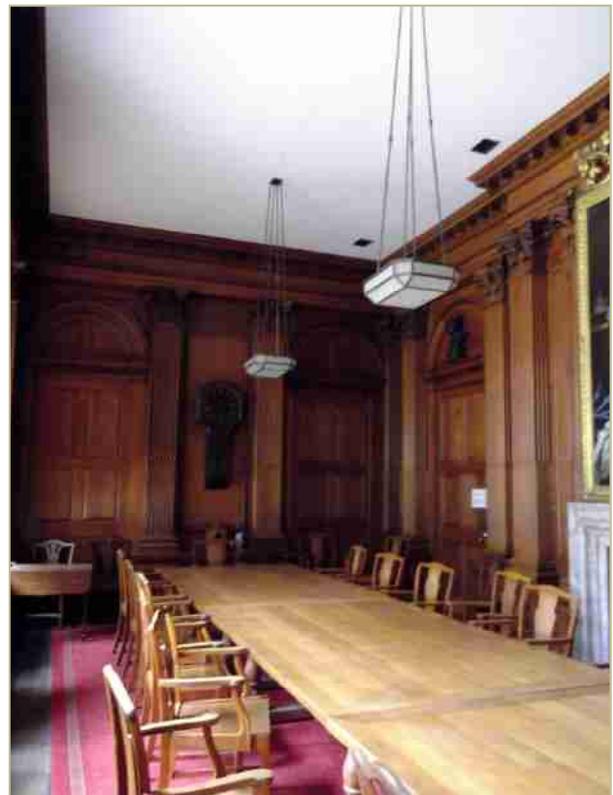
**Figure 14. 14.1, left, the Delegates' Room looking eastwards. 14.2, right, the Delegates' Room looking westwards**

The Delegates' Room is the most significant internal space in the building. It is of high aesthetic, illustrative, and associative value. The room is characterised by the original joinery of 1717-8. This consists of full-height panelling, with Corinthian pilasters separated by arches. The pilasters feel squeezed at each corner. There is an original marble mantelpiece and the picture above has an elaborate, garlanded overmantel. The ventilation ducts high up in the panelling and the four holes in the ceiling above the fireplace, described by Griffiths in 1882, are extant.<sup>79</sup> The doorways on the northern side of the room have been blocked and unblocked on several occasions, though the joinery has never been affected, with the doors either opening onto shallow cupboards or onto the northern room depending on the situation. The door on the eastern side originally opened onto a large closet, in the current location of the porter's lodge, but now opens onto a small passage created through later partitioning. Electrical lighting was fitted in the Delegates' Room in 1895, though the light fittings are substantially more modern.

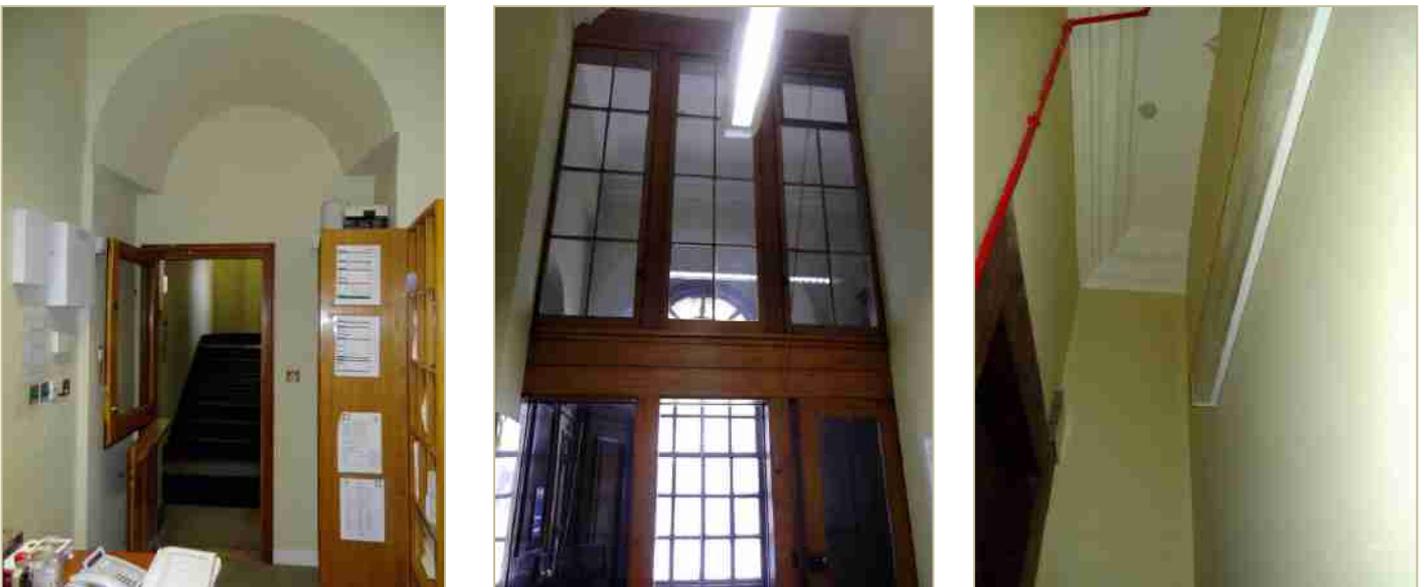
**Figure 15. 15.1, left, the reception looking northwards towards the 1976 doorway. 15.2, centre, looking southwards towards the 1929 partition and the antechamber of the Delegates’ Room. 15.3, right, the cornice moulding extending into the narrow passage space beside the Delegates’ Room**

Apart from the attractive fireplace, fittings within the reception are modern and its significance is illustrative regarding the changes in this part of the building during the 20<sup>th</sup> century.

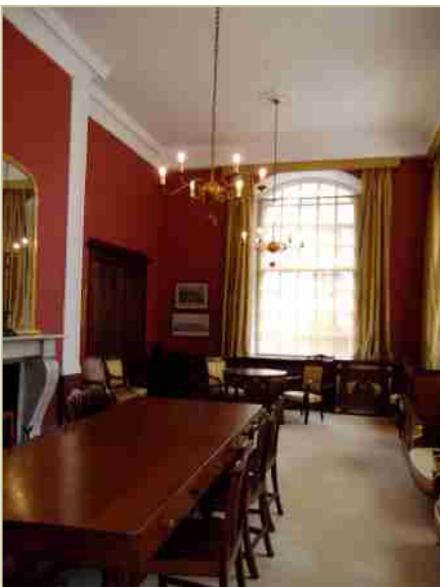
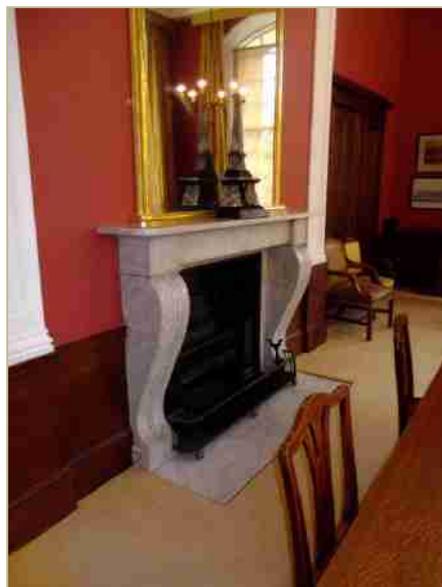
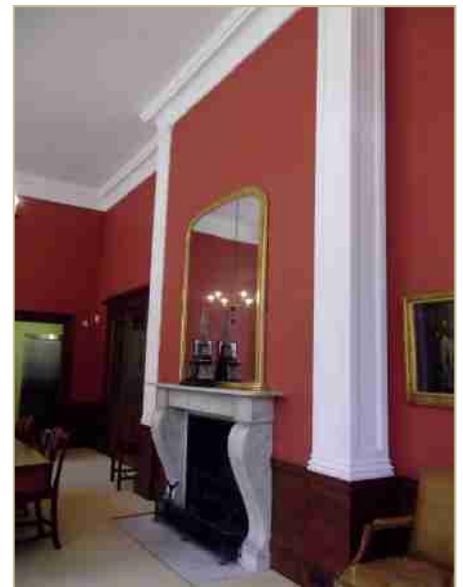
**Figure 17. 17.1, left, the Vice-Chancellor's office looking eastwards. 17.2, centre, the fireplace in the Vice-Chancellor's office. 17.3, right, the Vice-Chancellor's office looking north-westwards**

The room possesses extensive association value, having been the ceremonial office of the Vice-Chancellor of the University of Oxford for 180 years. The room provides the Vice-Chancellor with an appropriately-appointed room within the ceremonial heart of the University. Much of the furniture in the room originally belonged to Napoleon Bonaparte, having been collected by Lord Curzon of Kedleston, Chancellor of the University in 1907-25. Furthermore, there are 28 paintings and prints related to Napoleon in the room, also collected by Curzon.

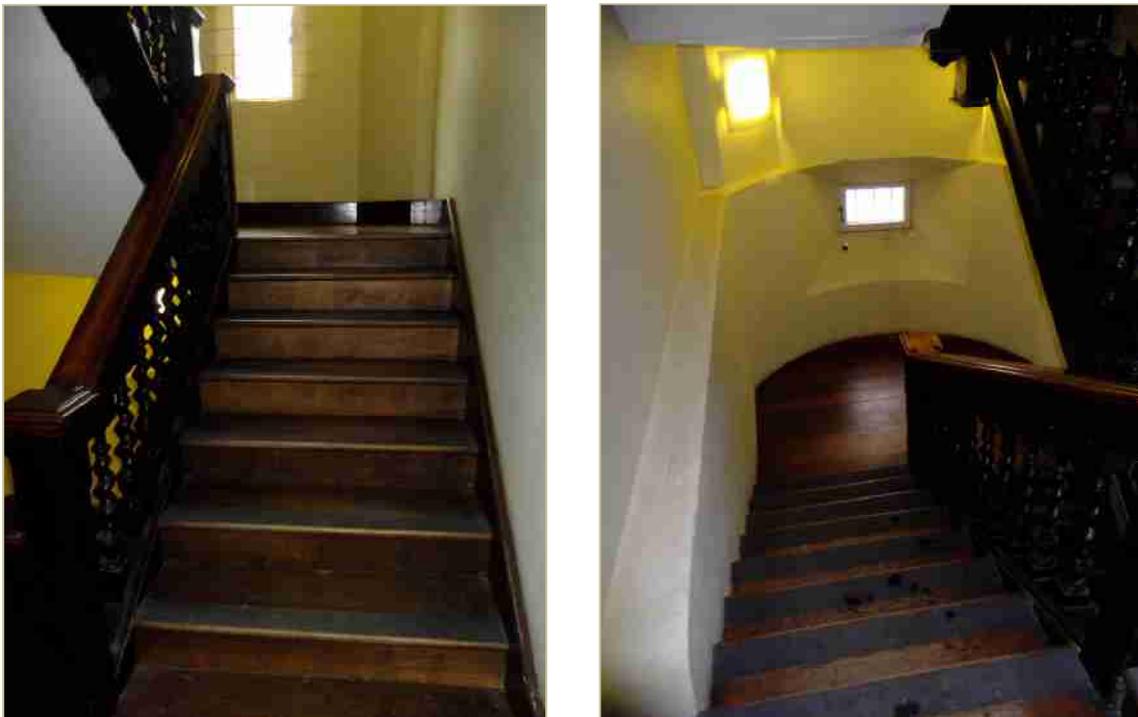
**Figure 19.19.1, left, looking up the eastern staircase. 19.2, right, looking down the eastern staircase towards the basement landing**

The original staircases are extant and are of high aesthetic and illustrative value. The main changes that have occurred in these spaces are: the installation of small windows at the basement landing level, at least one of which was fitted in 1920; the installation of a doorway into the area over the portico from the top of the eastern staircase in c.1950; the fitting of a security partition on the second landing of the western staircase in 1992; and the introduction of suspended ceilings over the first-floor landings in 2005, which also removed any exposed services, greatly enhancing the aesthetic value of the space. Several missing balusters were also replaced in 2005. Several steps were replaced in 1812 and certainly since.

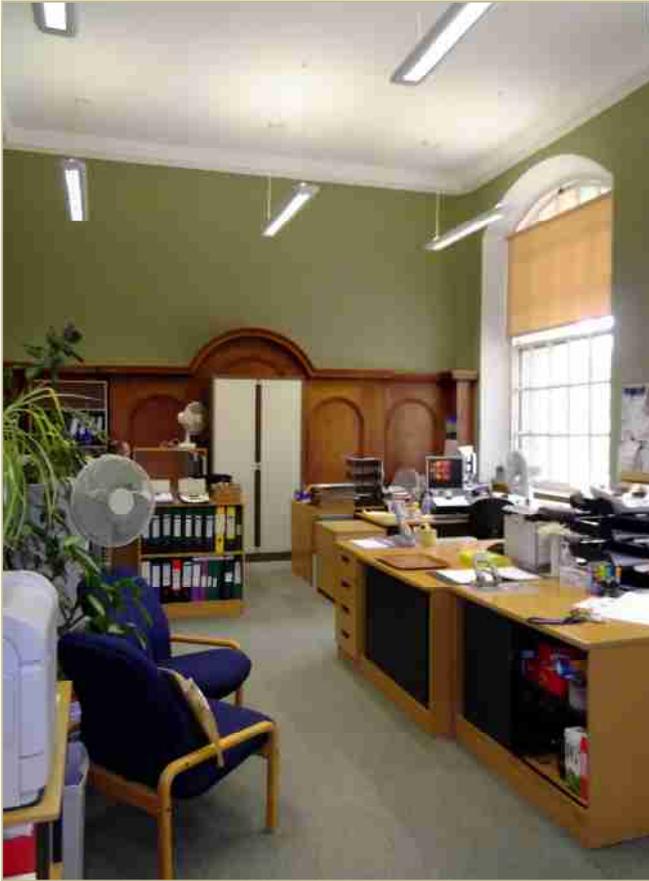
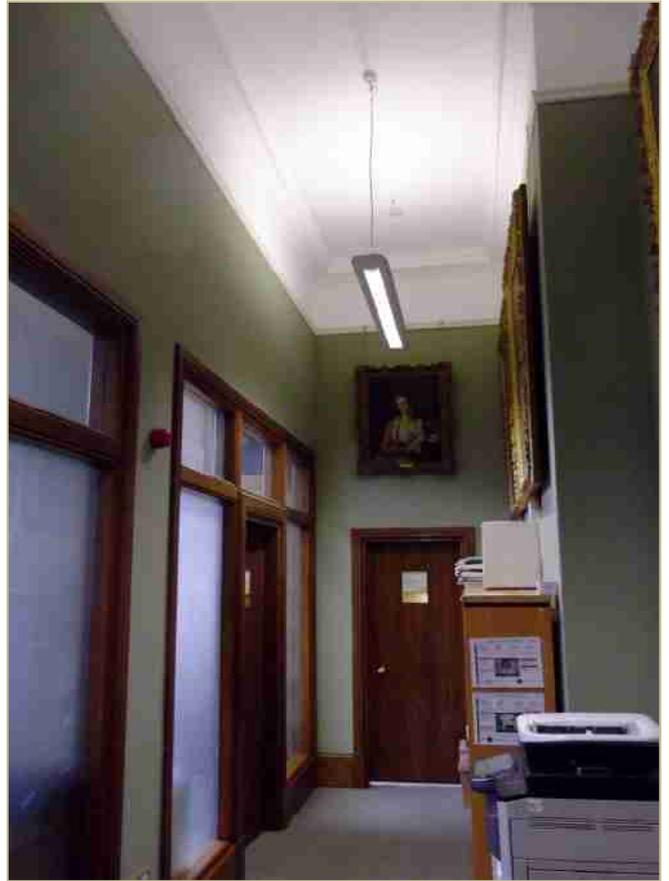
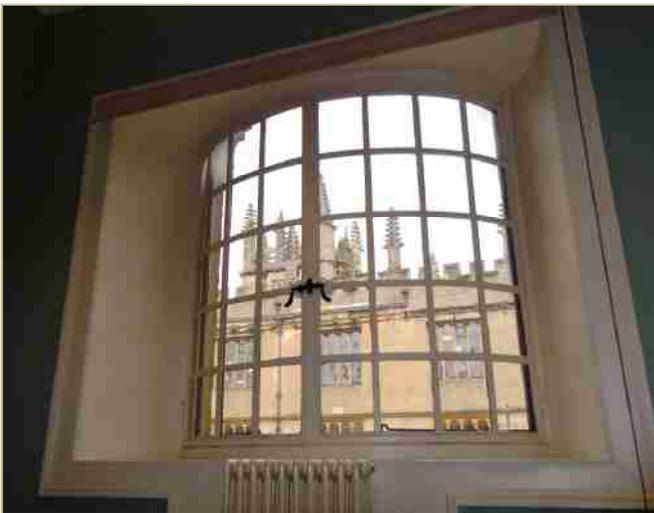
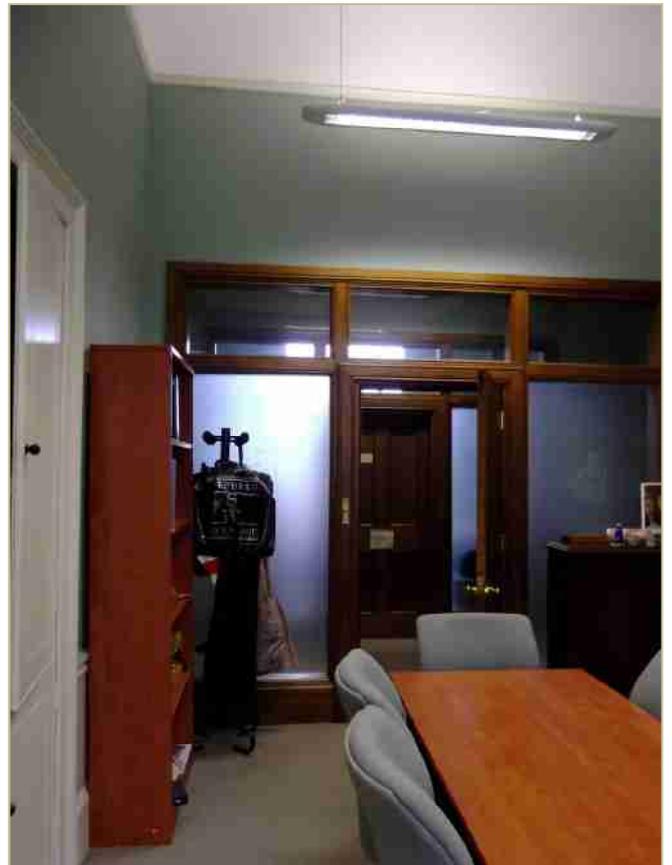
**Figure 20. 20.1, top left, south-eastern first-floor room looking eastwards. 20.2, top right, the partitioning in the north-eastern first-floor room looking eastwards. 20.3, bottom left, the curved window in the southern portion of the first-floor transept. 20.4, the first-floor transept looking northwards**

The southern portion of the first-floor transept, once the private room of the Reader in Geology, retains its fireplace and its curved window (enlarged in 1902 and 1933) onto the niche once occupied by Clarendon's statue (**Figure 20.3**).

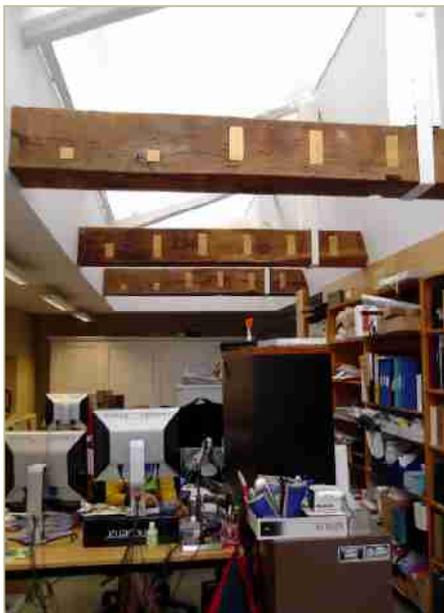
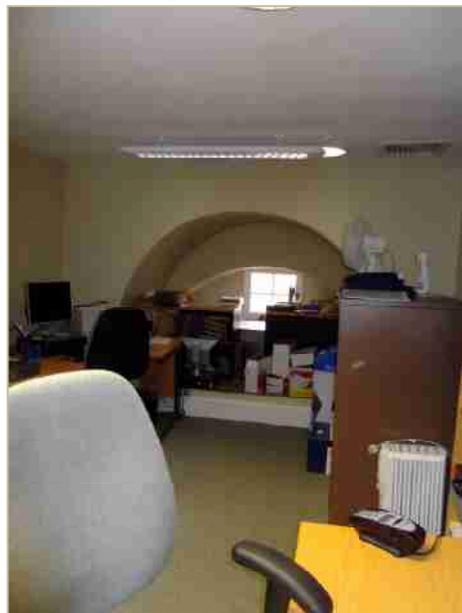
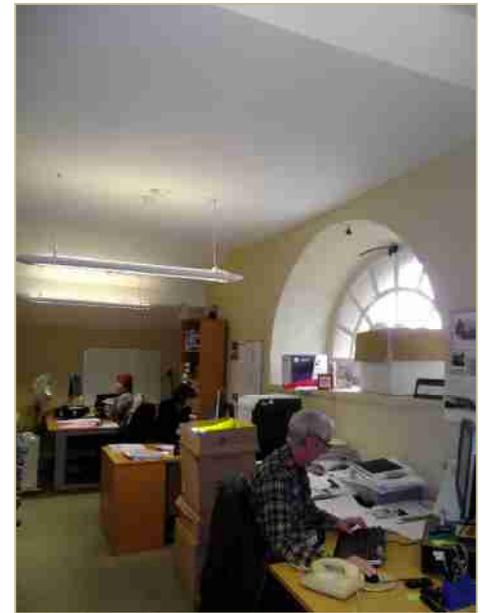
**Figure 21. 21.1, left, south-eastern second-floor office looking west. 21.2, centre, frieze-level window in south second-floor transept looking south. 21.3, right, second-floor office over the portico looking north-westwards**

The area over the portico now serves as an office space, lit by the semi-circular window on the tympanum (**Figure 21.3**). The arched opening into the transept was a glazed fire escape until 2005 but is now blocked, with the room being accessed from a doorway at the top of the eastern staircase since c.1950.

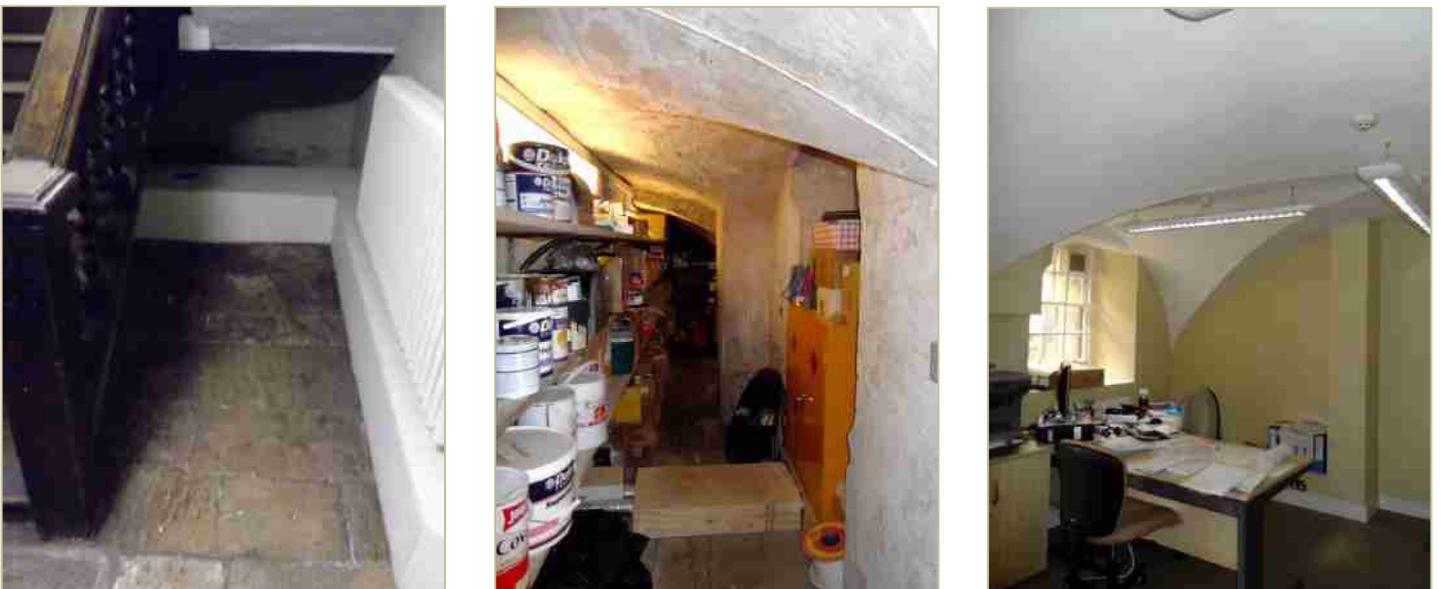
**Figure 22. 22.1, left, paving in the basement lobby. 22.2, centre, storeroom and historic cell in the northern part of the basement. 22.3, office in the south-eastern portion of the basement**

The basement areas were heavily partitioned throughout the 19<sup>th</sup> and 20<sup>th</sup> centuries. The current configuration is similar to that reached by 1962, the only major difference being in the south-eastern area (now occupied by the Museum of the History of Science), parts of which were occupied by WCs until 2005. The basement has some associative value, having housed some unique University of Oxford institutions, most notably the University Police. Their cells (now storerooms) in the northern part of the basement are damp and rather bleak spaces, striking for their historic function.

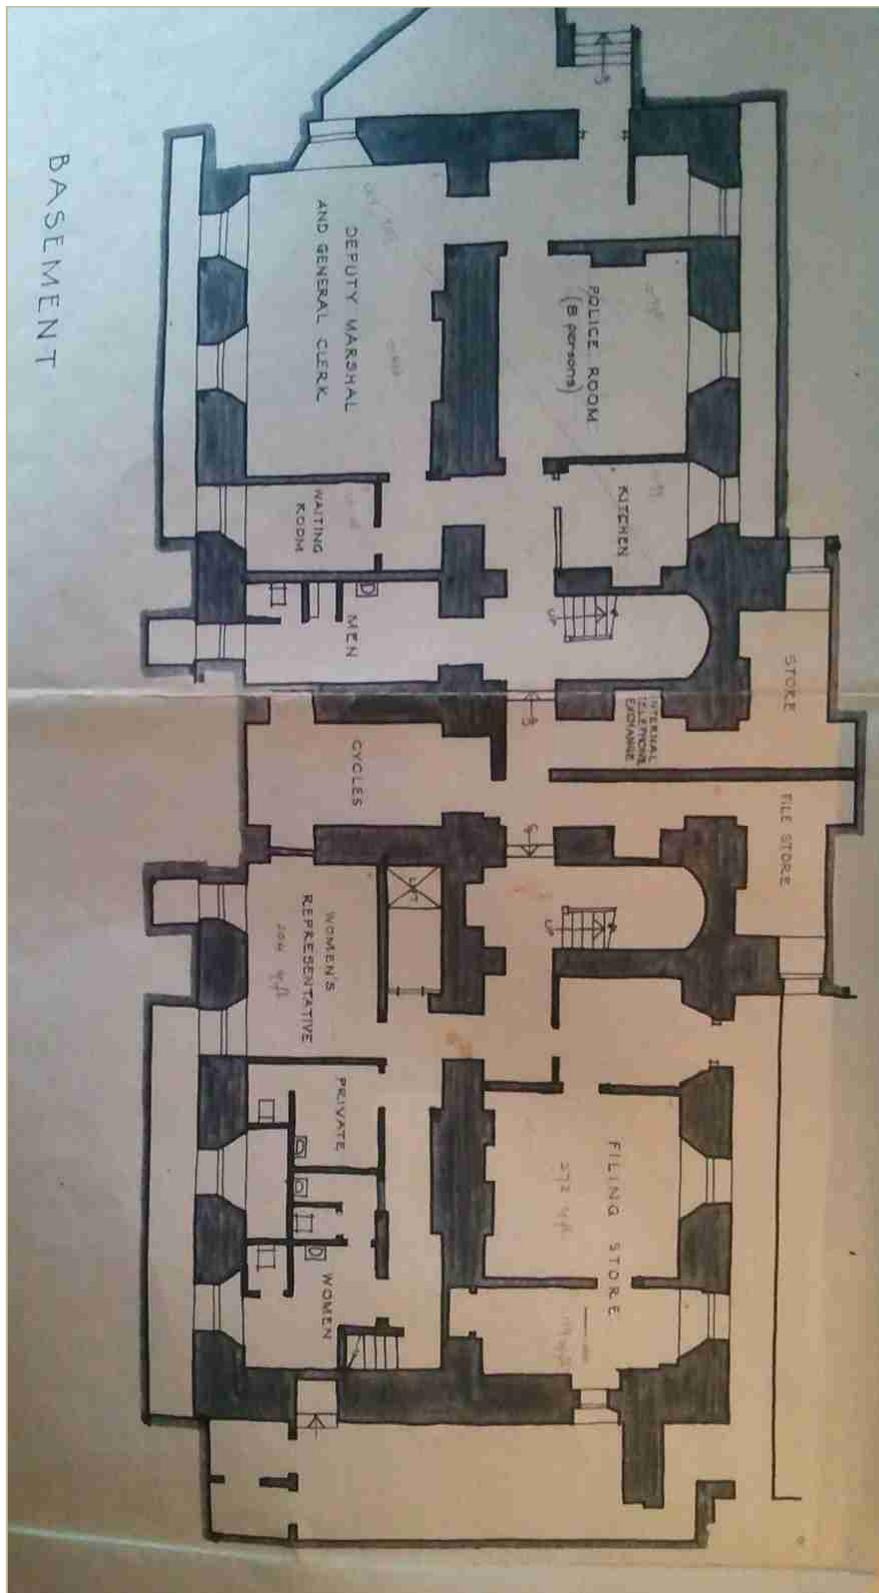
### 5.2.1 Basement plan (north at the right-hand side of the image)

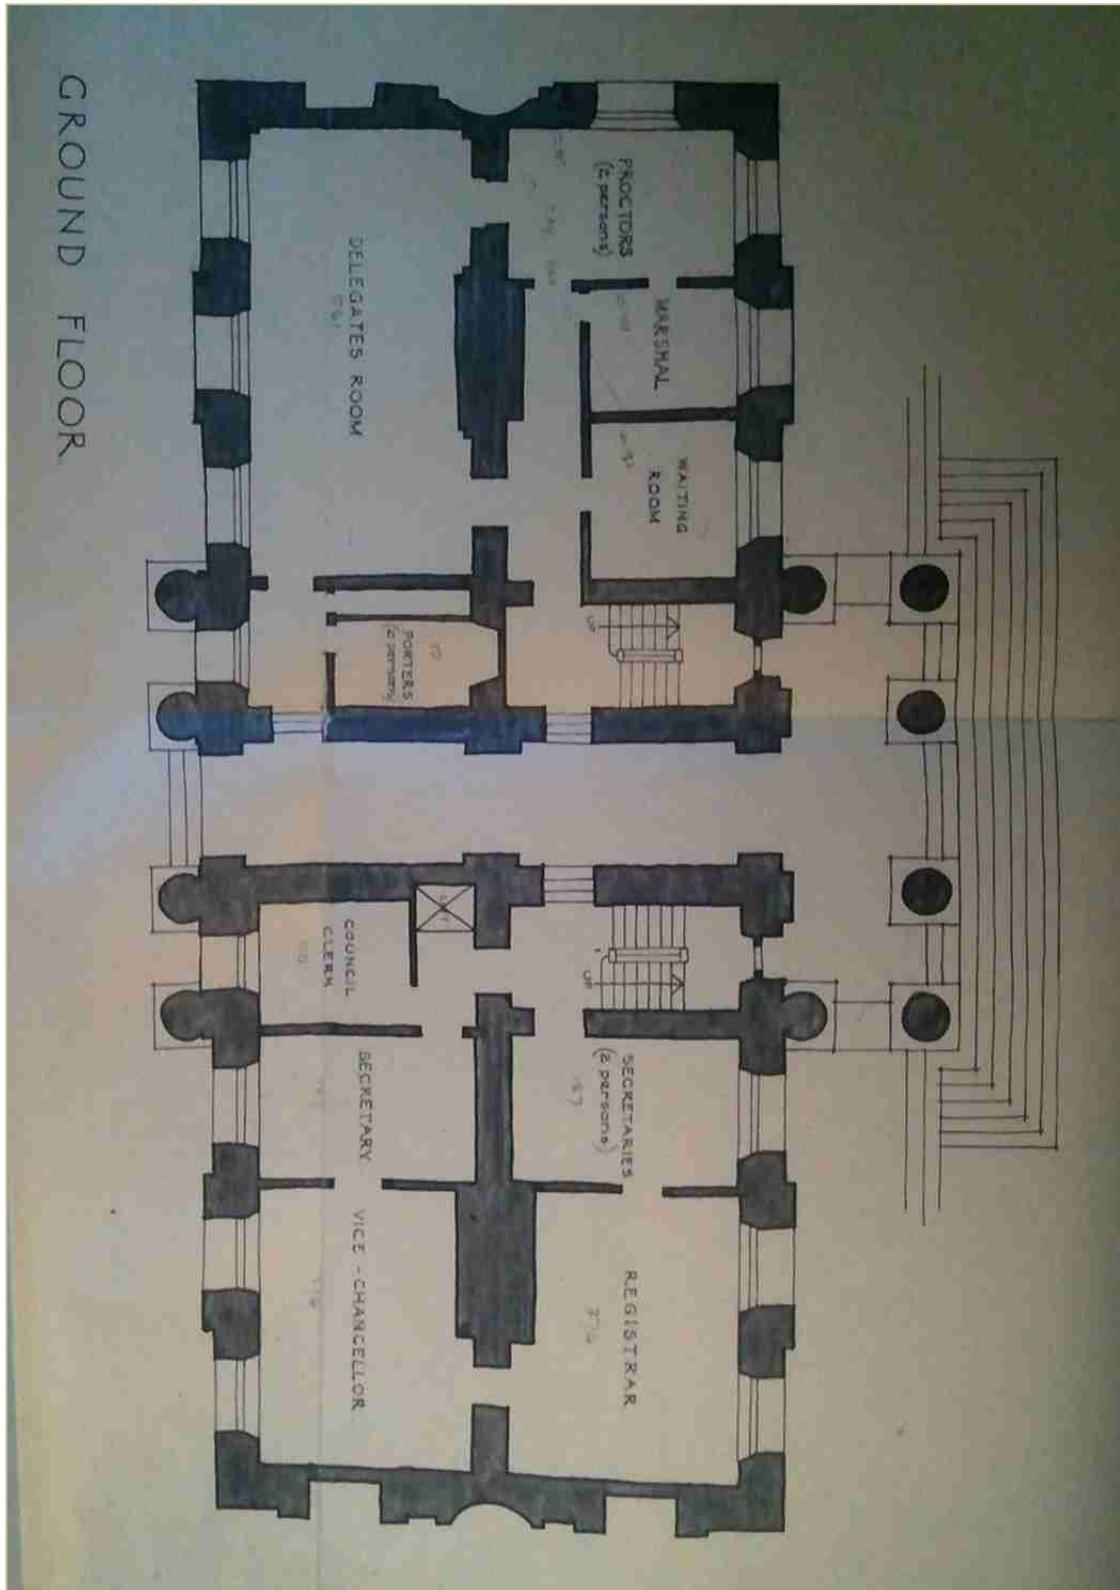
5.2.2 Ground-floor plan (north at the right-hand side of the image)

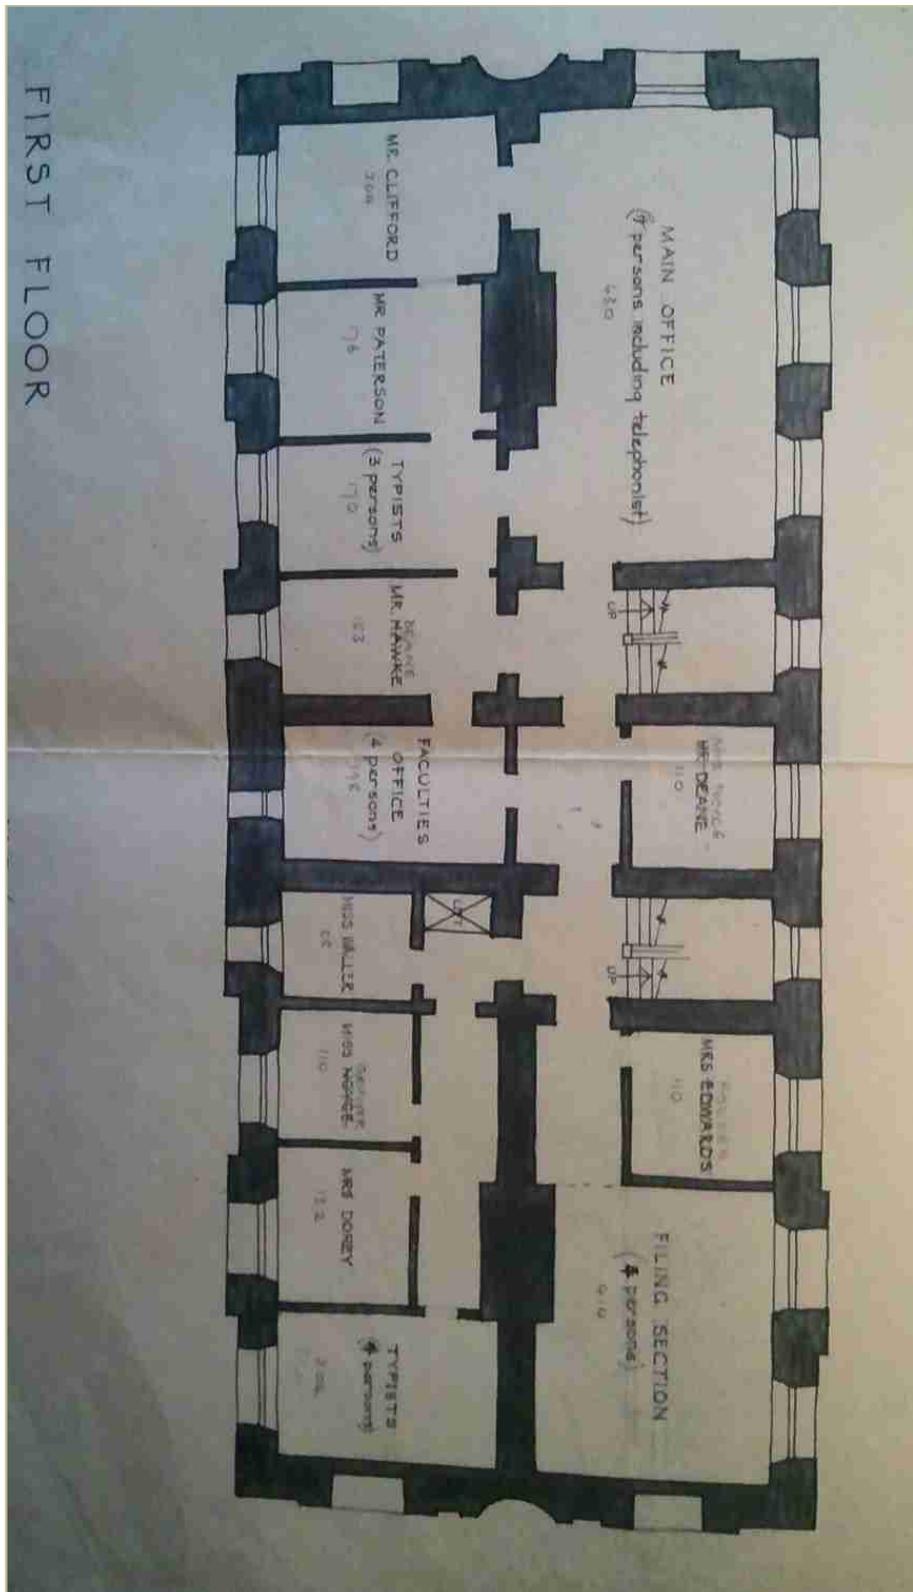
5.2.3 First-floor plan (north at the right-hand side of the image)

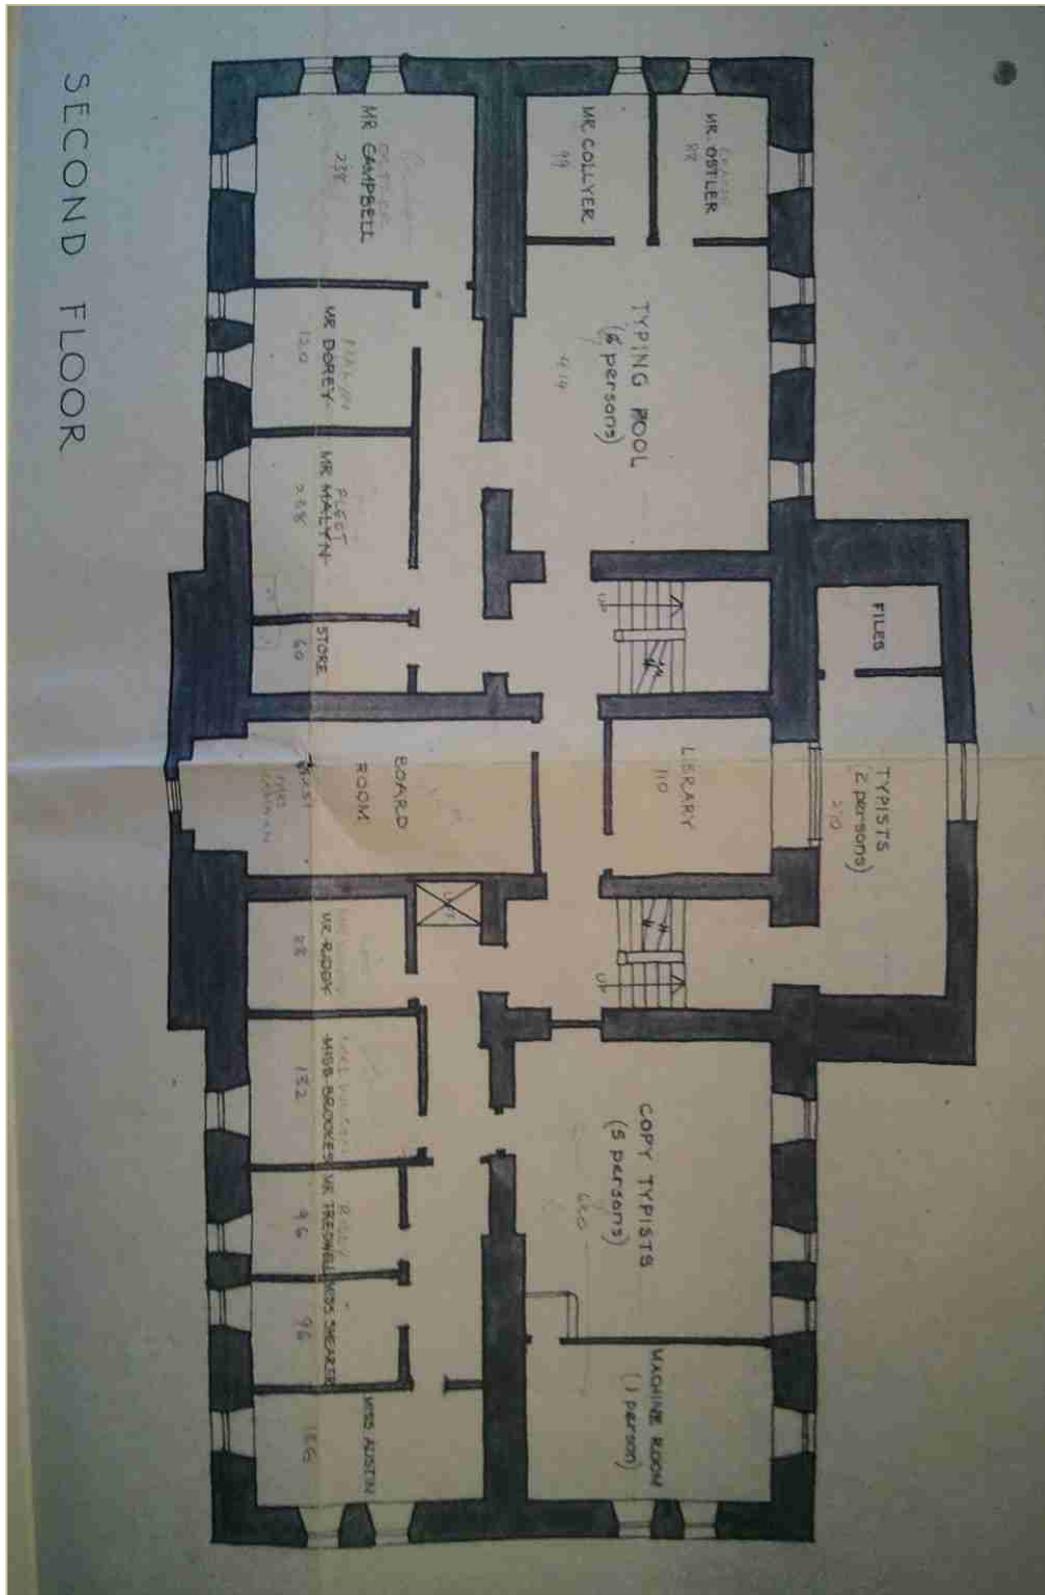
5.2.4 Second-floor plan (north at the right-hand side of the image)
