**The Clarendon Building  
Conservation Plan**

Building No. 144  
April 2013

**Estates Services**  
**University of Oxford**  
**April 2013**

## CONSERVATION PLAN

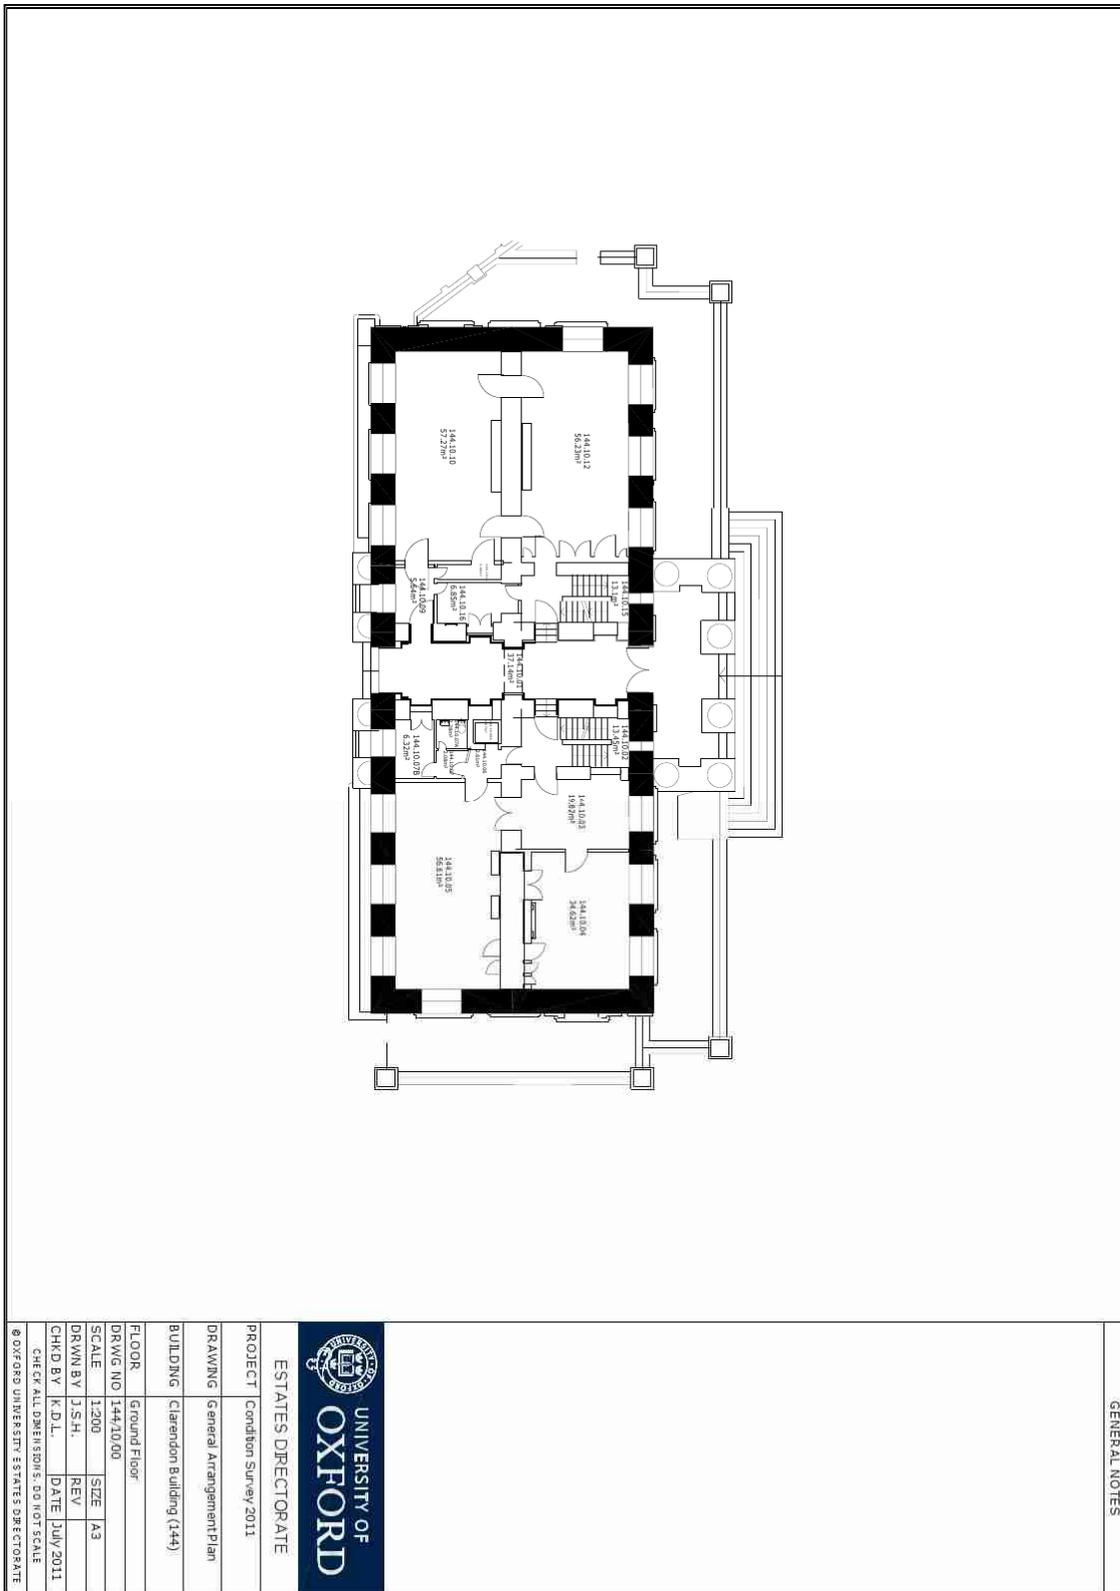
5.3.2 Ground-floor plan (north at the right-hand side of the image)

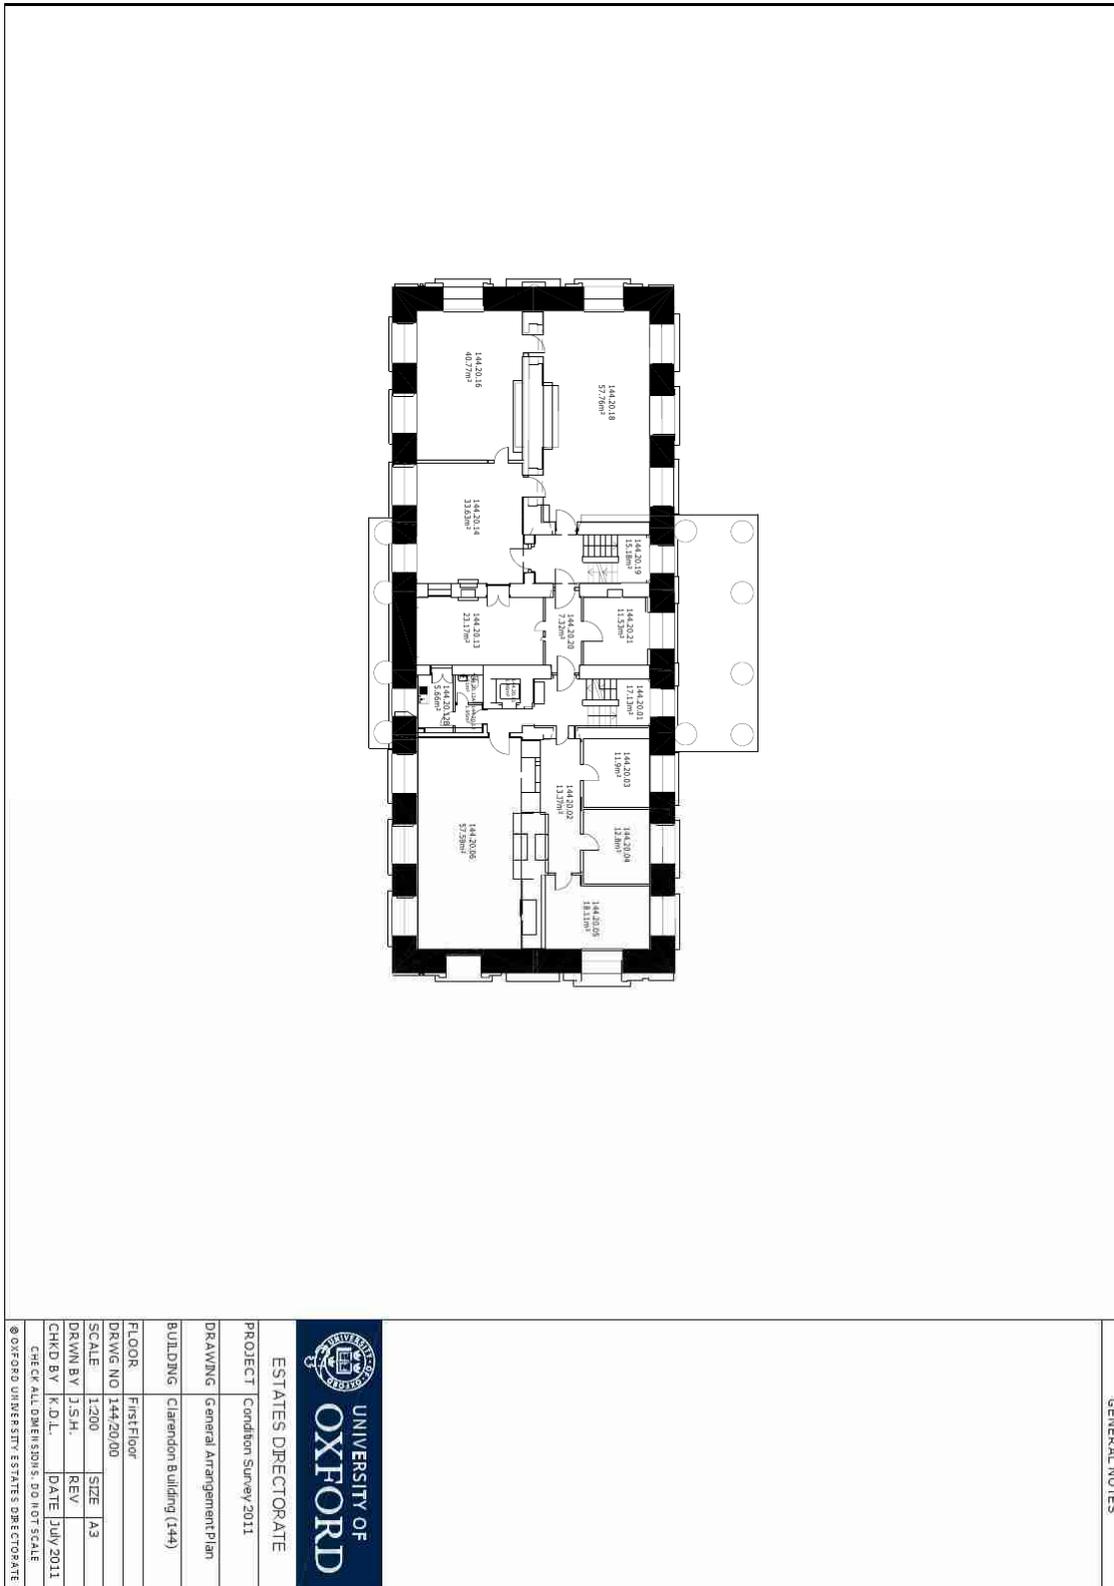
### 5.3.3 First-floor plan (north at the right-hand side of the image)
