Science Area Landscaping: HV Repairs

Weekly Newsletter 9

The Week Ahead 30th Aug – 9th Sep

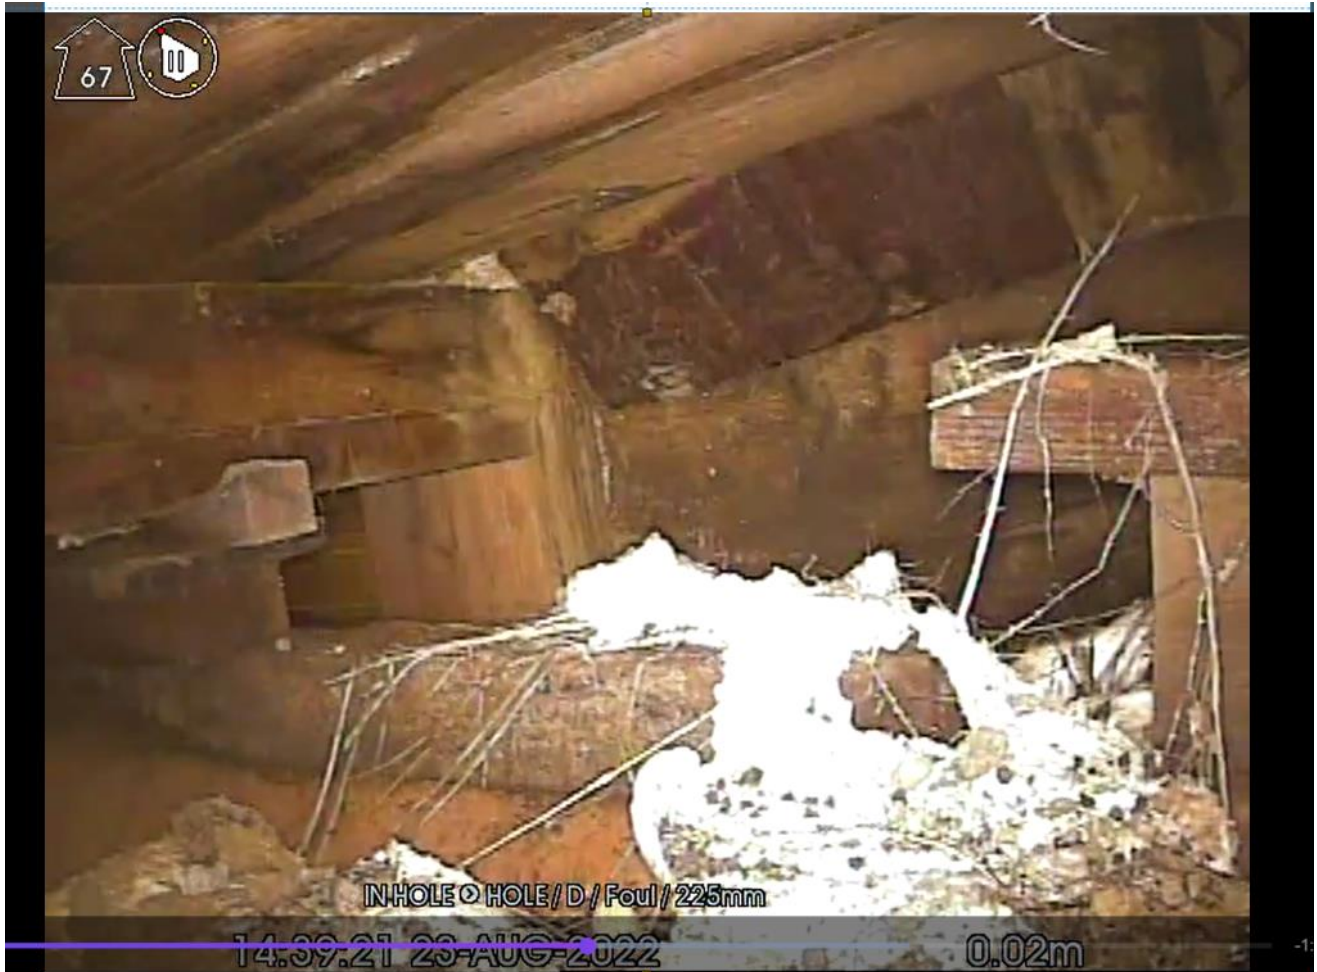
- Snapshot of CCTV footage of timber structure identified at approx. 3-4 metre depth

Firstly, The GPR managed to ascertain the extent of the anomaly in areas that the CCTV could not reach and the CCTV has determined why the void has been created. At a depth of approximately 3 – 4 metres the camera was able to record a wooden structure that looked as though it had been constructed as protection work for the sewage pipe during historical works (speculative). This structure was never removed and was subsequently backfilled leaving a void. We believe since the area had been backfilled, surface water has been slowly eroding the upper levels of sand and subbase via a broken duct from a telecoms chamber and with the void created by the structure, this has been slowly flowing downwards into that void/area.

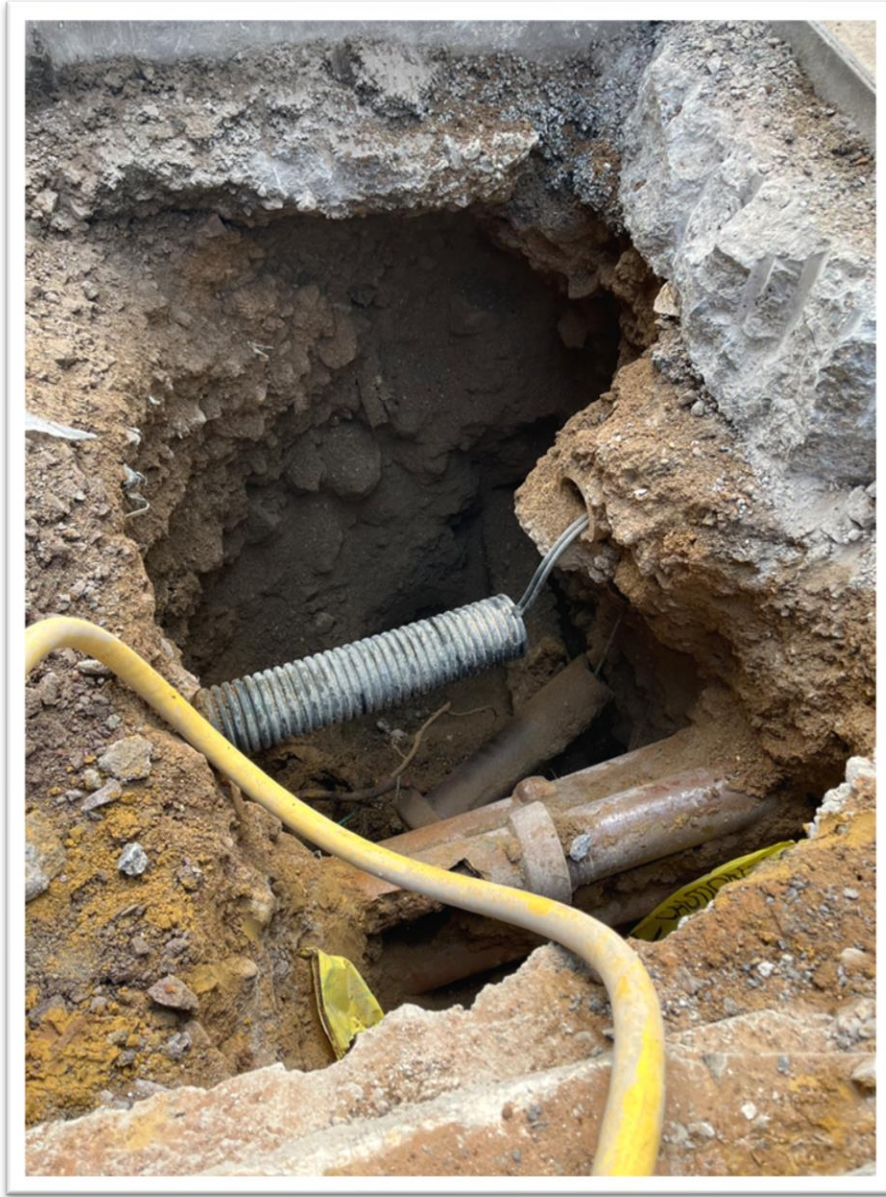
- Upper void at LGCP entrance.
